# VEHICLE INSPECTION REPORT

**GK22DZE**

## Daf XF 530

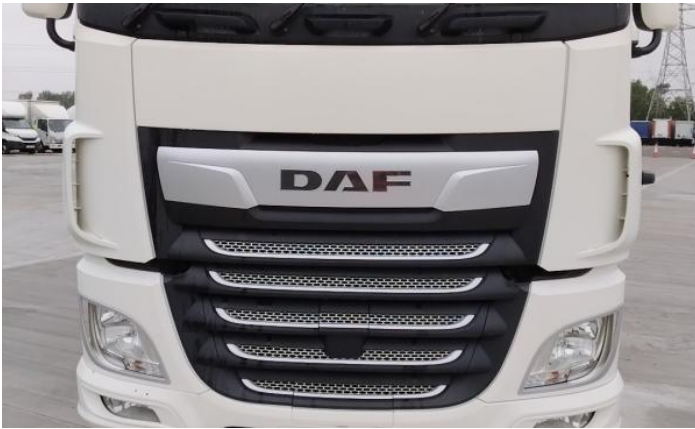
1: Bonnet  
Chipped  
Multiple Chips

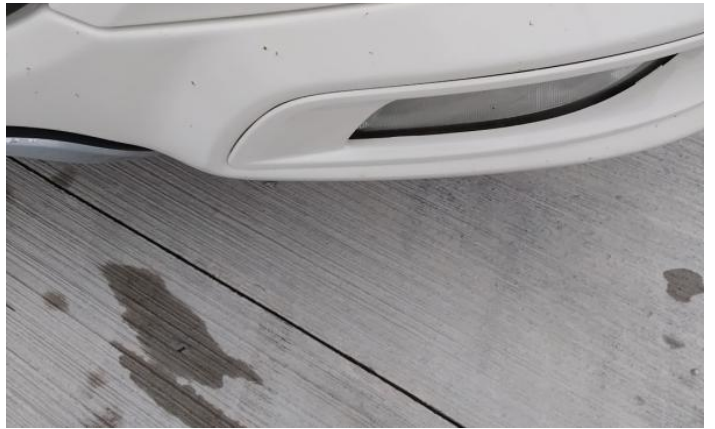
2: Bumper Front  
Rusted  
UpTo 5mm

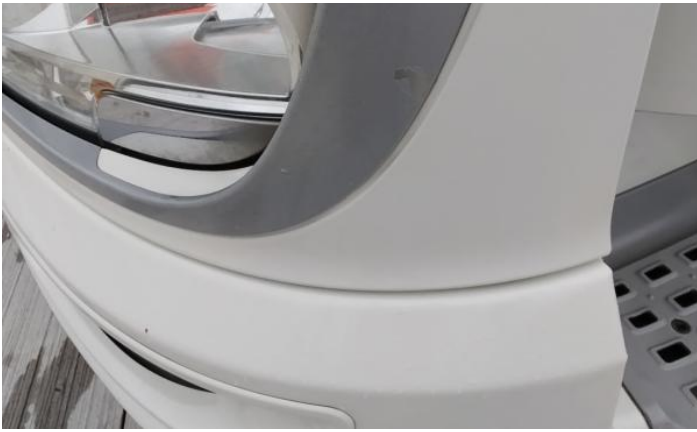
3: Bumper Front Moulding  
Scratched (Painted)  
Over 25mm Thru Paint

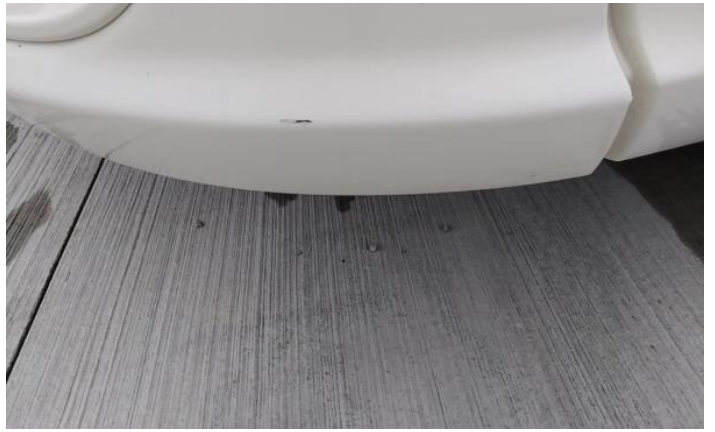
4: Bumper Front  
Scratched  
Up To 25mm Thru Paint

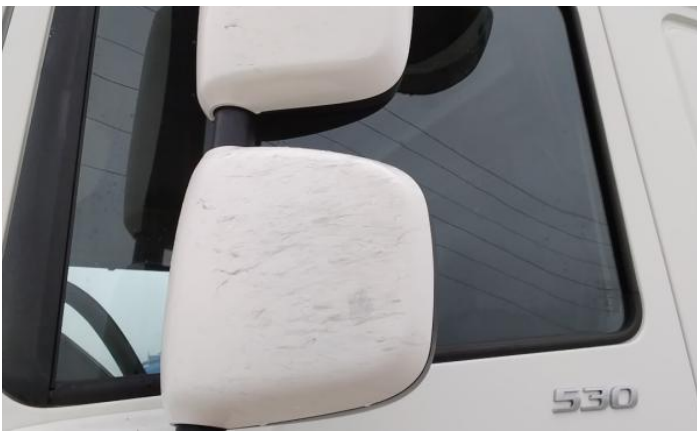
5: Door Mirror Assy nsf  
Scuffed (Unpainted)  
Over 100mm

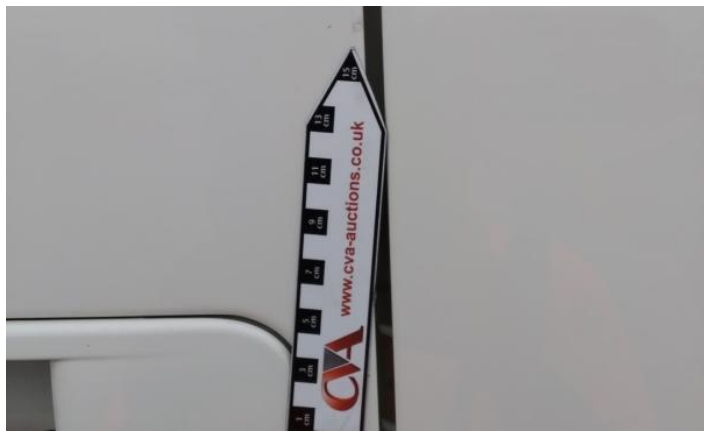
6: Door nsf  
Poor Previous Repair  
Poor Paint

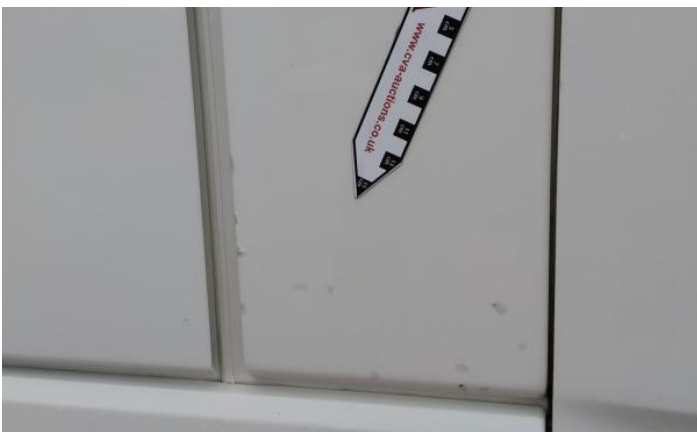
7: Qtr Panel nsr  
Poor Previous Repair  
Poor Paint

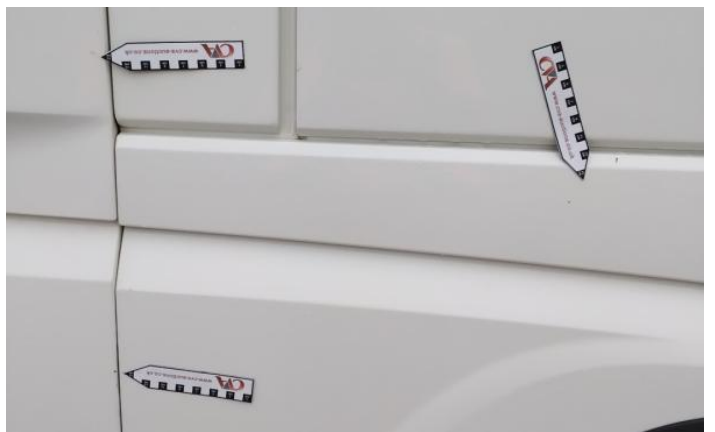
8: Qtr Panel osr  
Chipped  
Multiple Chips

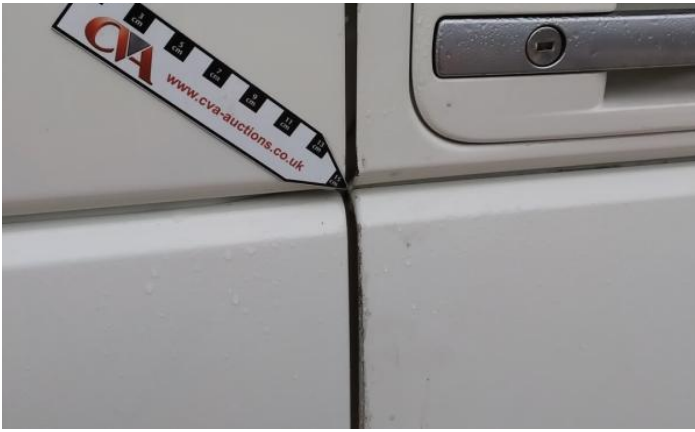
9: Door osf  
Chipped  
Multiple Chips

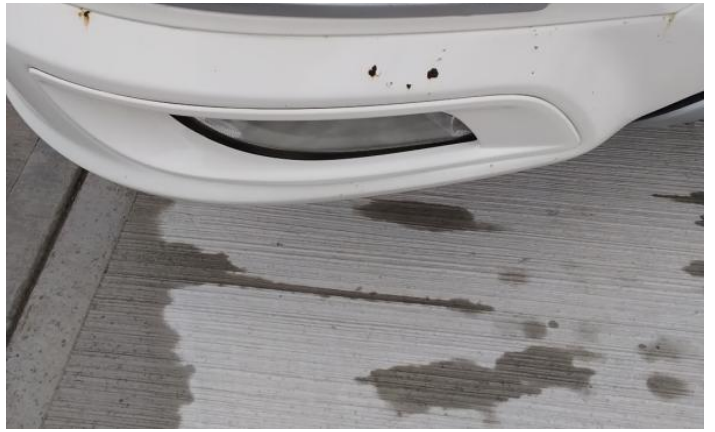
10: Bumper Front  
Rusted  
Over 5mm

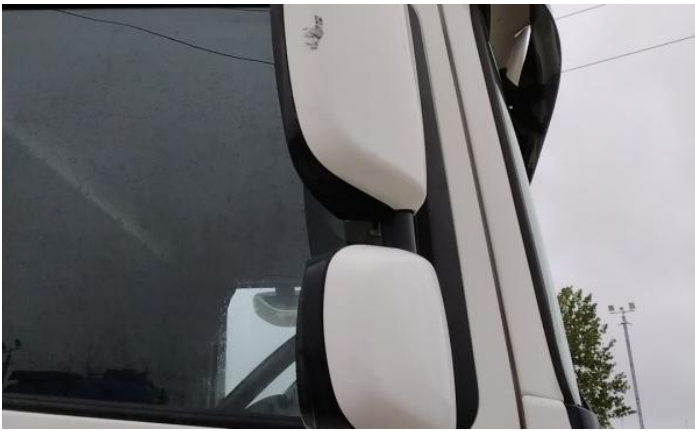
11: Door Mirror Assy osf  
Scratched (Painted)  
Over 25mm Thru Paint

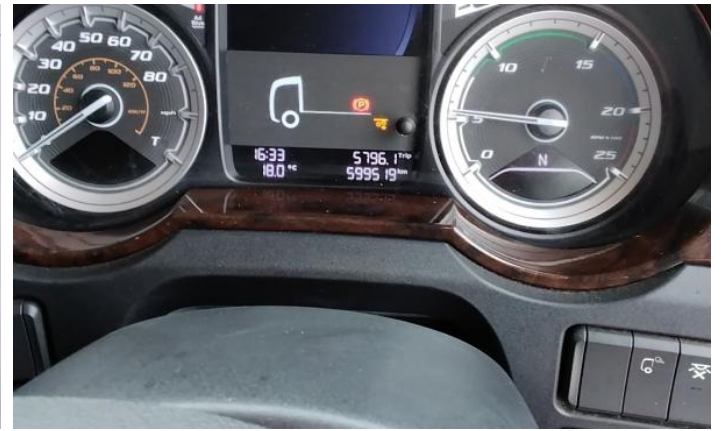
12: Dash Warning Lights  
Displayed  
No Action
