# VEHICLE INSPECTION REPORT

**GK22DZE**

## Daf XF 530

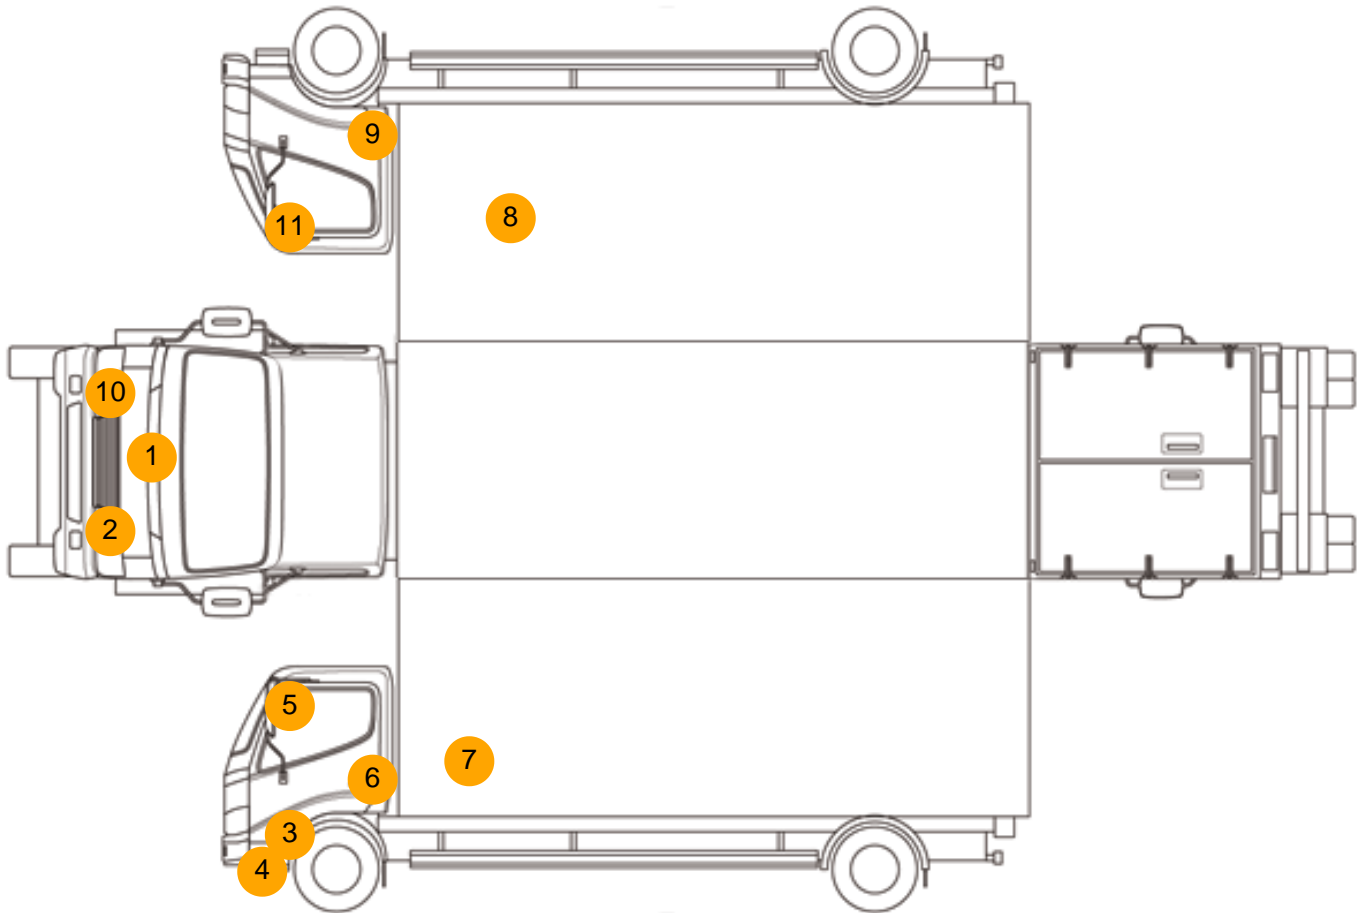
## Condition Check

2: Bumper Front  
Rusted  
UpTo 5mm

6: Door nsf  
Poor Previous Repair  
Poor Paint

7: Qtr Panel nsr  
Poor Previous Repair  
Poor Paint

10: Bumper Front  
Rusted  
Over 5mm
